FOREST PARK UPPER DAM
MA 00568

PHASE I INSPECTION REPORT
NATIONAL DAM INSPECTION PROGRAM

DEPARTMENT OF THE ARMY
NEW ENGLAND DIVISION, CORPS OF ENGINEERS
WALTHAM, MASS. 02154

SEPTEMBER 1979

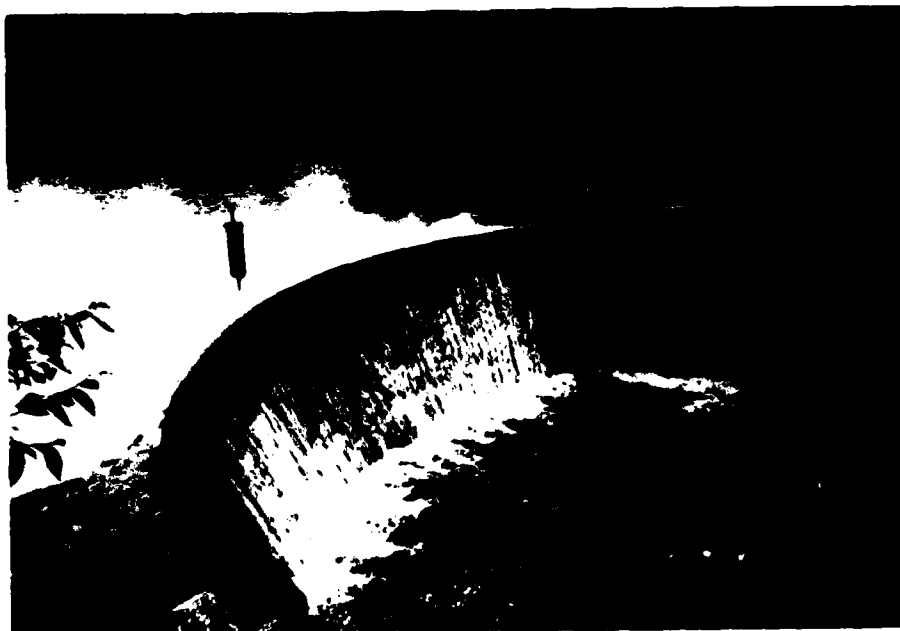
8. OVERVIEW OF SPILLWAY AT UPSTREAM FACE OF DAM.

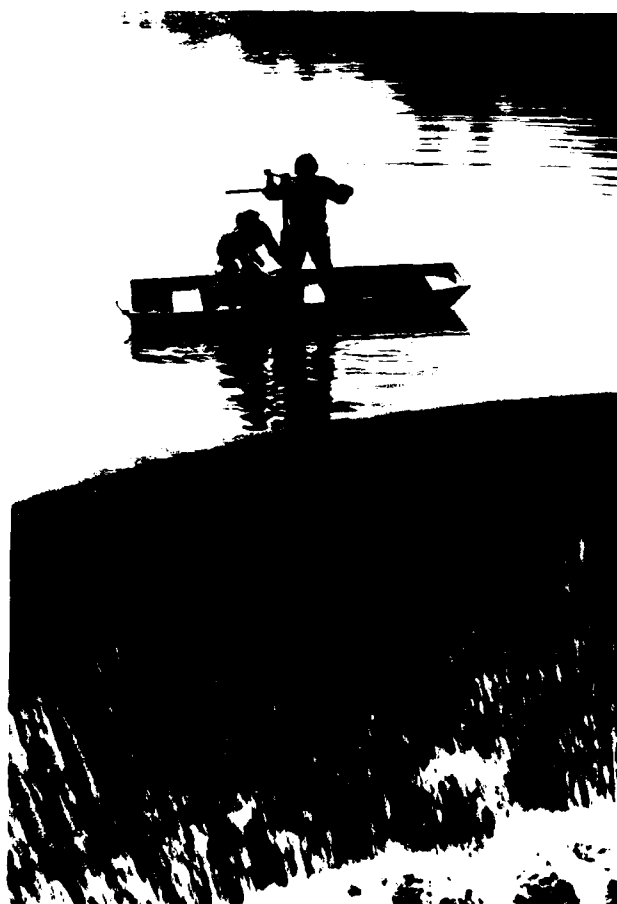
- (7) The mortar plaster on the underside of the culvert roof is cracked and pieces have fallen off.
- c. Appurtenant Structures - The reservoir drain is controlled by a gate operator on the upstream side of the spillway. The gate is operational. Access to the gate during normal or high flows is by boat as shown in Photos 8 and 9.

8. PEASUICK DRAIN OPERATOR UPSTREAM OF SPILLWAY. NOTE
DRAIN CUTS AT BOTTOM RIGHT OF PHOTO.

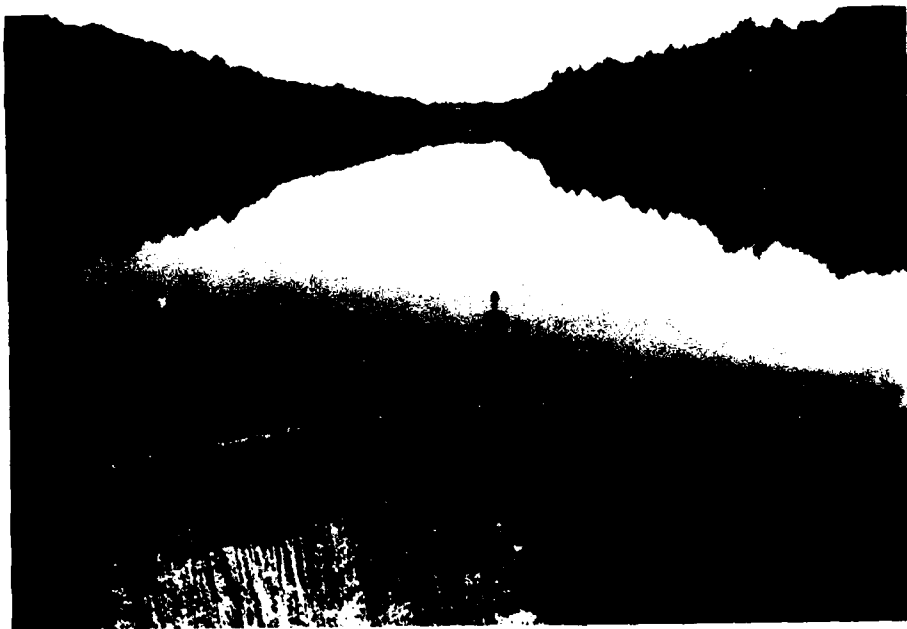
- d. Reservoir Area - Forest Park Upper Dam forms an impoundment called Porter Lake in Forest Park. There is no development in the vicinity of the reservoir area as shown in Photo 9, except for park facilities. There is a park concession building at the right bank just upstream of the dam. Side slopes to Porter Lake are generally flat to moderate. There appears to be no potential for landslides into the reservoir which would cause waves to overtop the dam. No conditions were noted which might result in a sudden increase in sediment load into the reservoir.

OVERVIEW OF UPSTREAM POND WITH PORTION OF SPILLWAY CREST AND
RESERVED GRAIN OPERATOR IN FOREGROUND
